PLANNING NOTICE

APPLICANT:	MZSR Developments - PA\24\0233
PROPERTY ADDRESS:	5 Meander Valley Road CARRICK (CT: 94801/3)
DEVELOPMENT:	Demolition of buildings & Multiple dwellings (6 units) - private open space, privacy, design & layout of parking areas, pedestrian access, traffic generation, attenuation distance, potentially contaminated land.

ACC # 371799313 ABN. 71 615 812 747 PH. 6344 7319 E. info@designtolive.com.au W. designtolive.com.au	CLIENT/S: MZSR DEVELOPMENTS	DRAWING COVER PAGE	I/WE APPROVE THESE DRAWING TO BE CORRECT PER CONTRACT.		COPYRIGHT: This is the sole property of Design To Live, and may not be used in whole, or in part without written or formal consent from Design To Live. Legal action will be taken against any person/s infringing the copyright.	REV.	DATE	DESCRIPTION	DESIGNER	M.L.	JOB NUMBER	MNDR05
	SITE ADDRESS: LOT 3 (5) MEANDER VALLEY ROAD, CARRICK TAS, 7291.		SIGNATURE:	DATE:		R1	16/04/2024	FOR REVIEW	DRAWN	D.M.	DRAWING	1/22
			SIGNATURE:	DATE:		R2	24/04/2024	FOR DA	CHECKED	M.L.	SCALE (@A3)	NTS

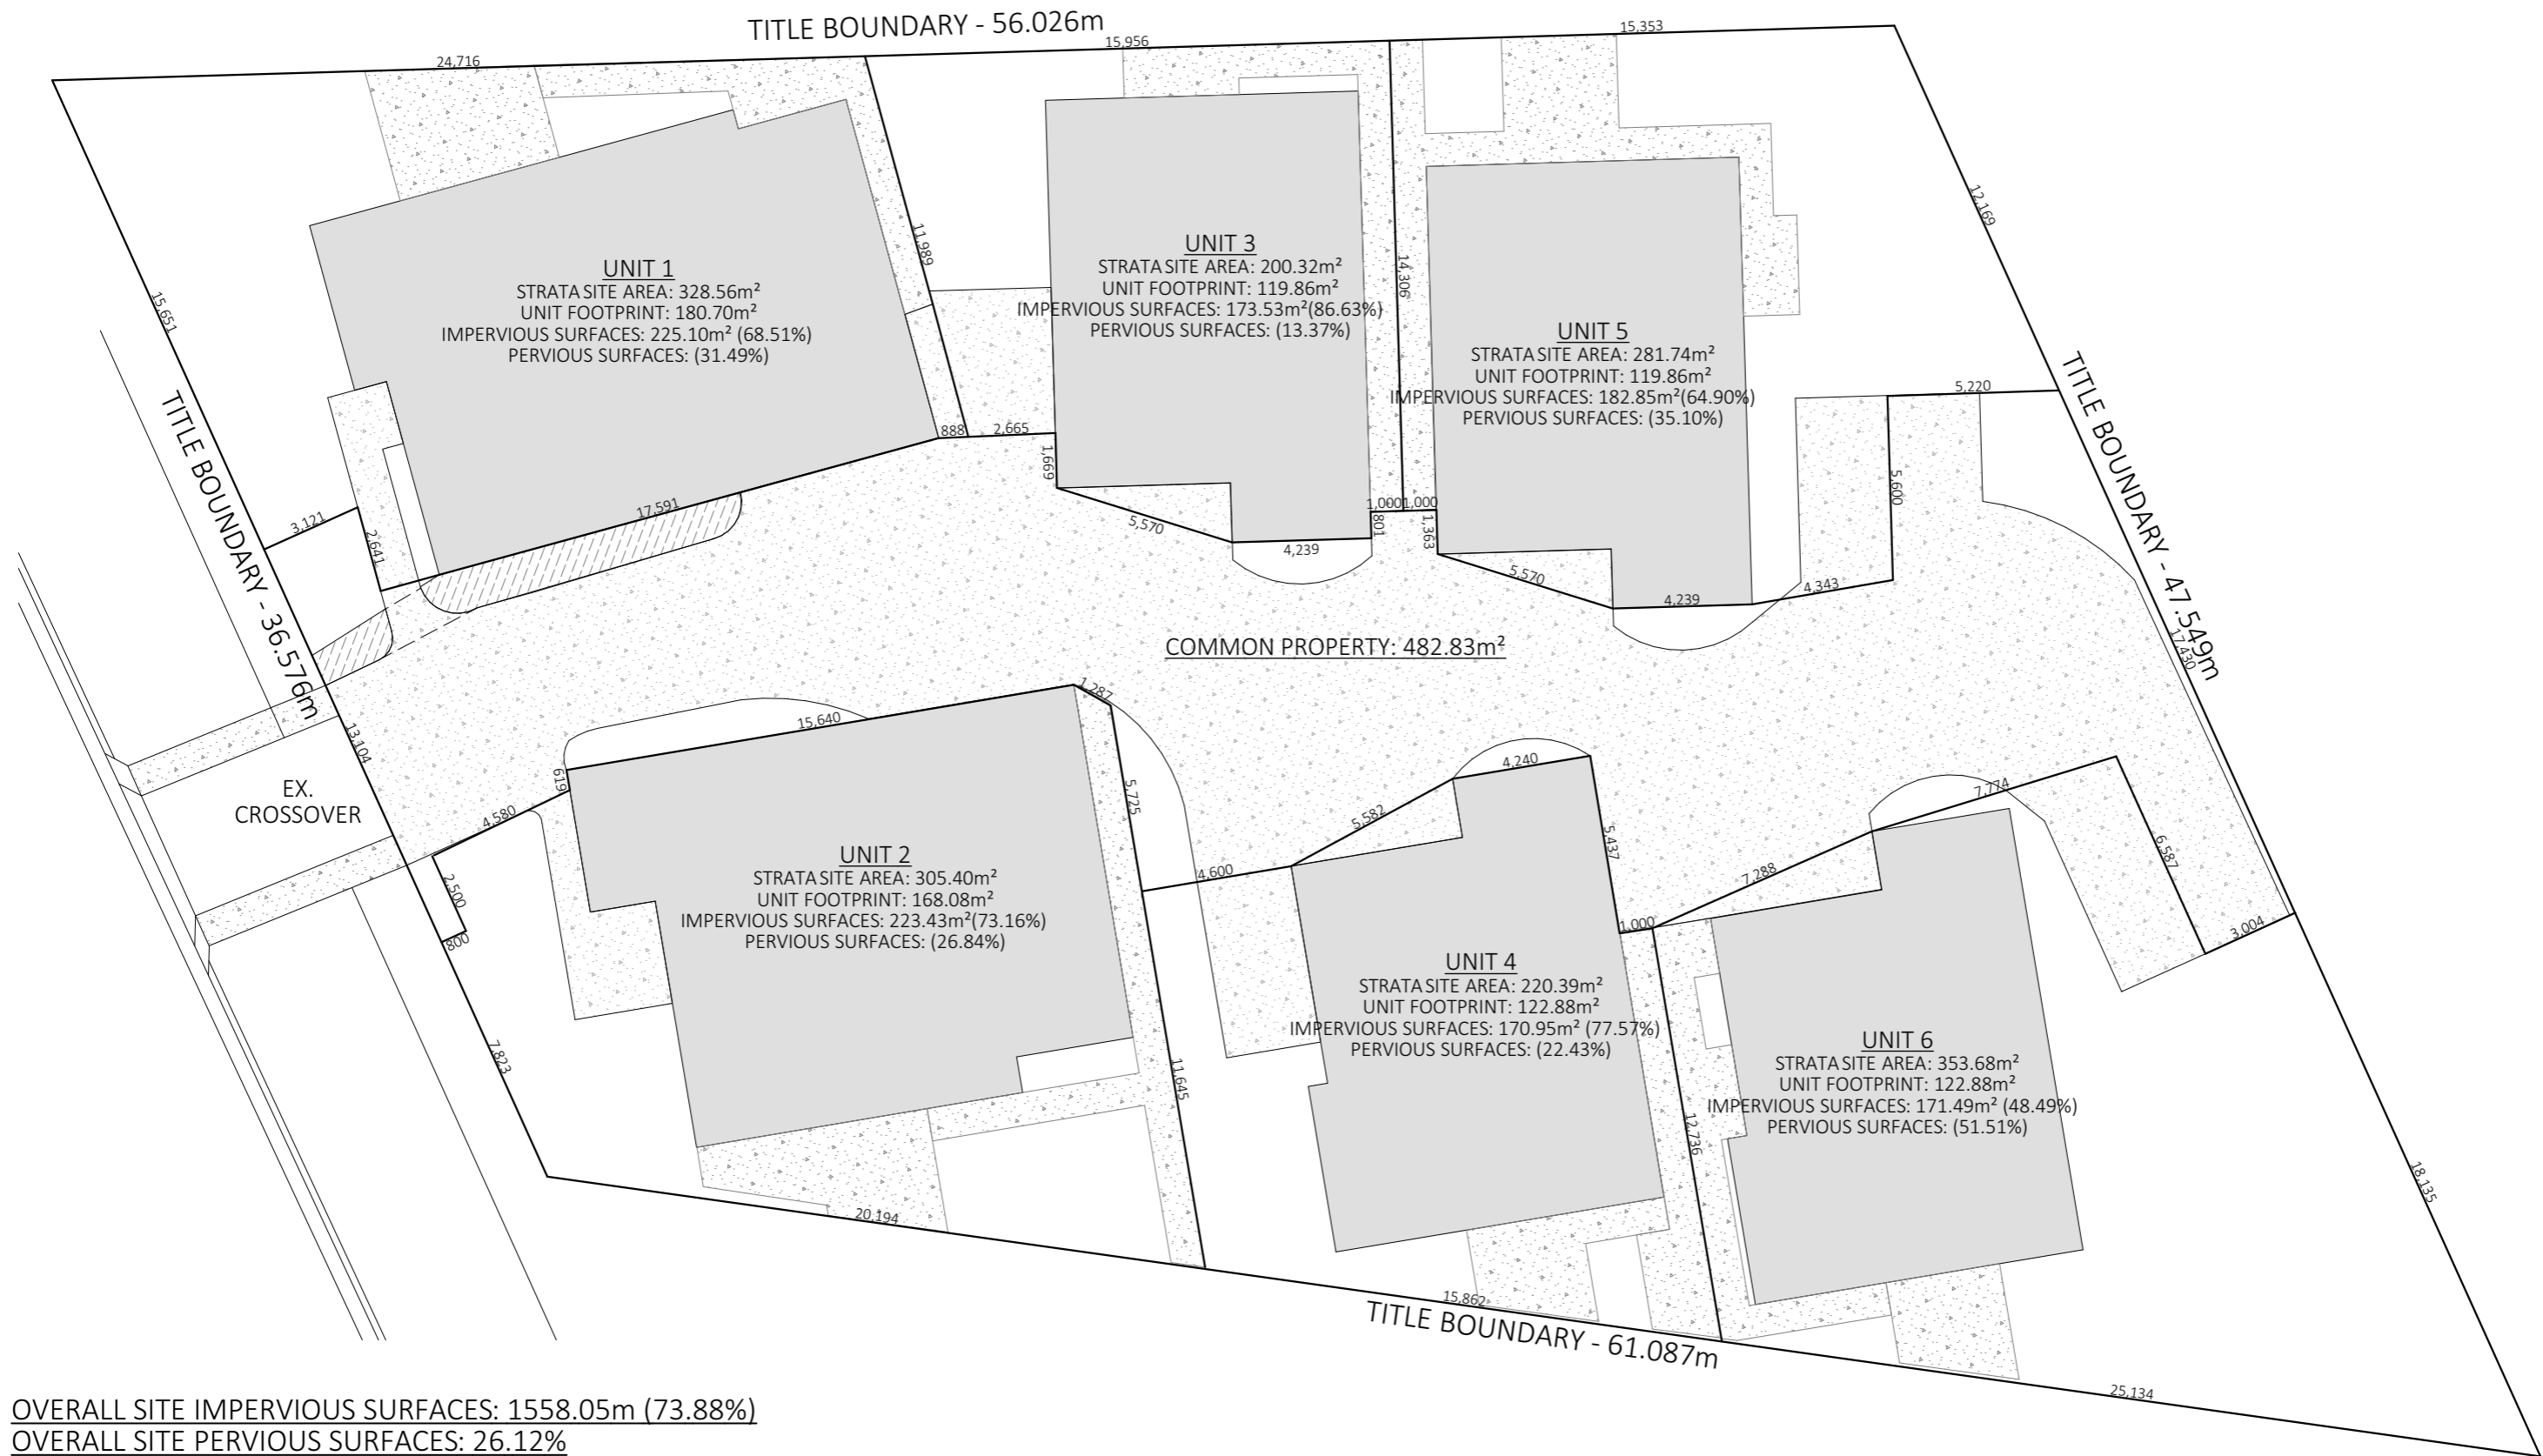
OVERALL SITE IMPERVIOUS SURFACES: 1558.05m (73.88%)
OVERALL SITE PERVIOUS SURFACES: 26.12%

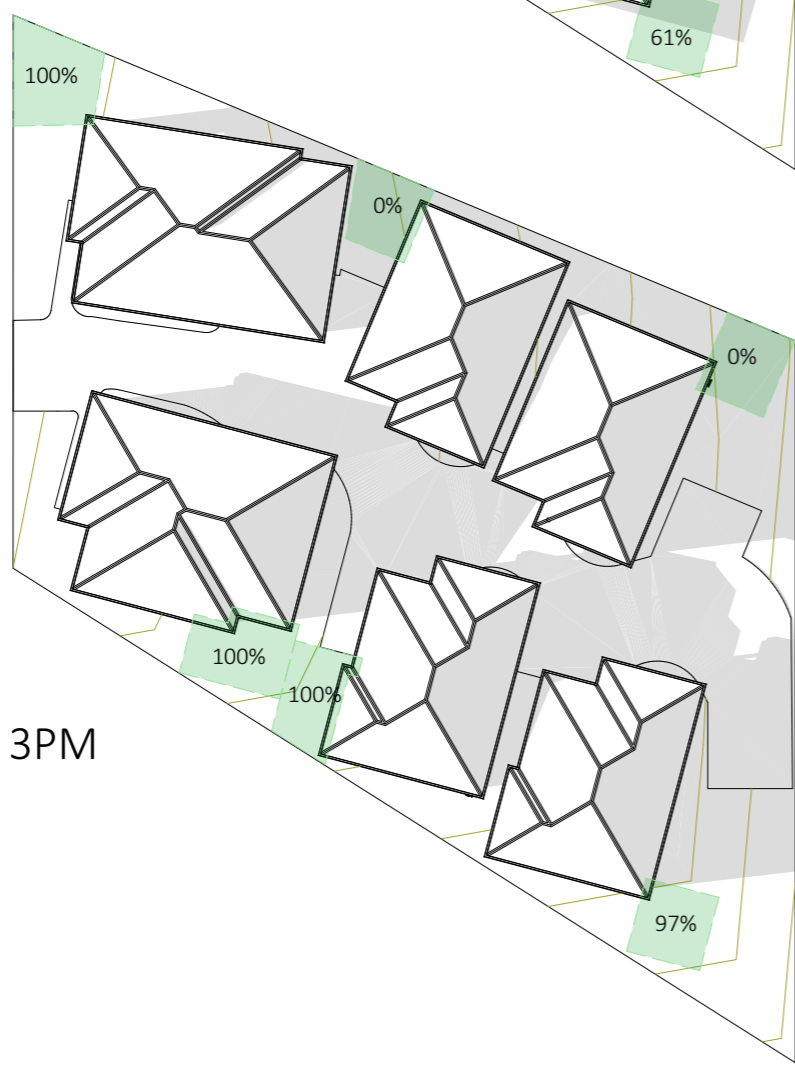
- PRIVATE OPEN SPACE

NOTE:
PERCENTAGE SHOWN
REPRESENTS AREA OF
DEDICATED PRIVATE OPEN
SPACE WITH DIRECT SUNLIGHT
ACCESS.

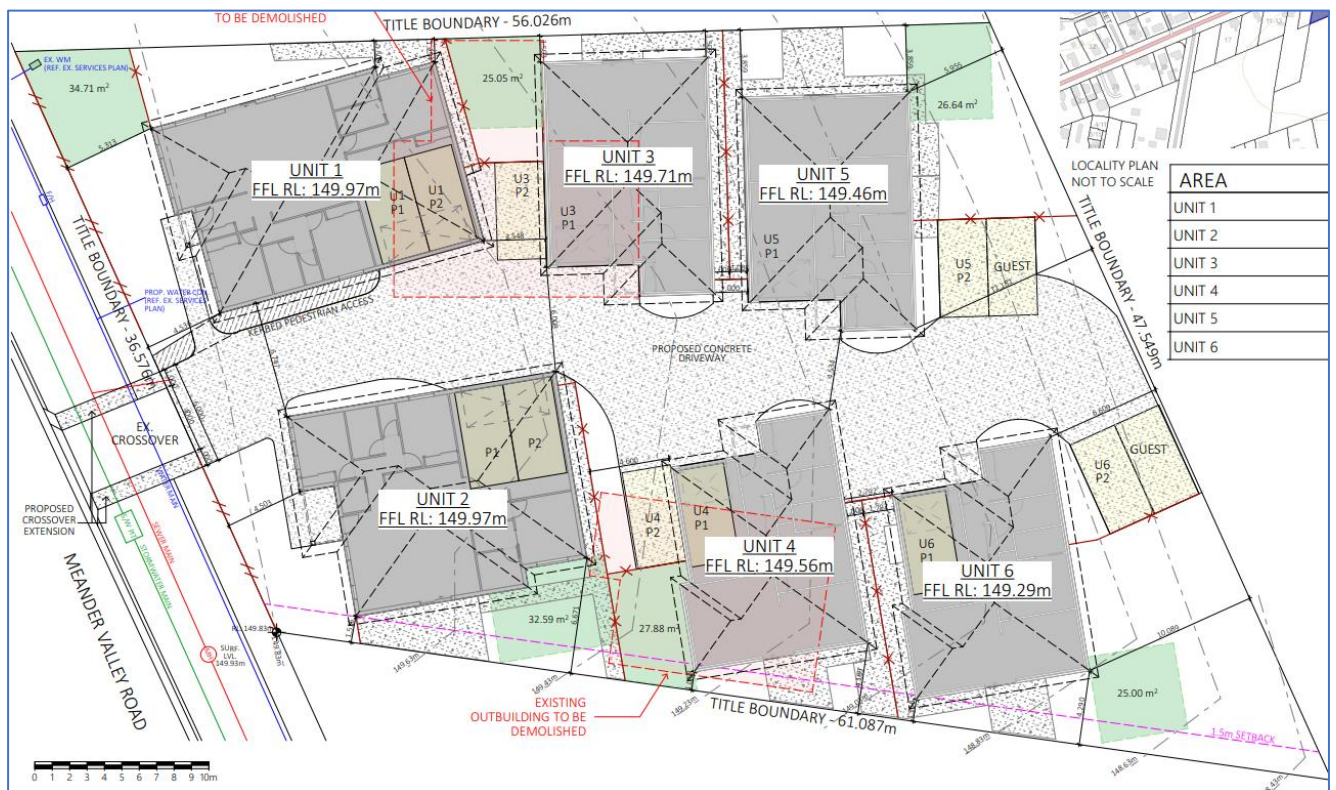
Diagram 3.0 – Development proposal

As advised by the developer, the existing dwelling and outbuilding will be removed for the construction of six new residential units, which will consist of four two-bedroom and two three-bedroom units.

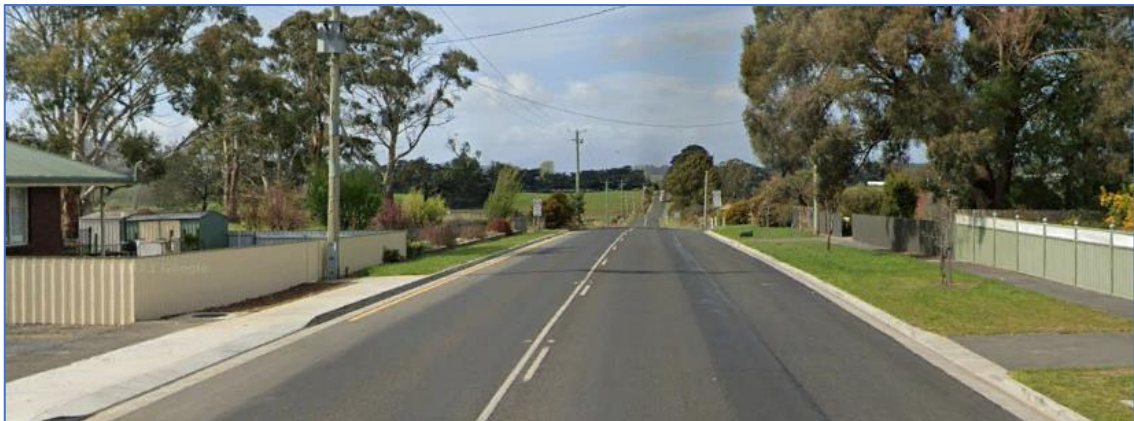
Photograph 5.1A – Image from Google Earth of Meander Valley Road

When the on-street parking lane along the southern side is not in use, vehicles can turn into the site from the parking lane, minimising the traffic flow impact.

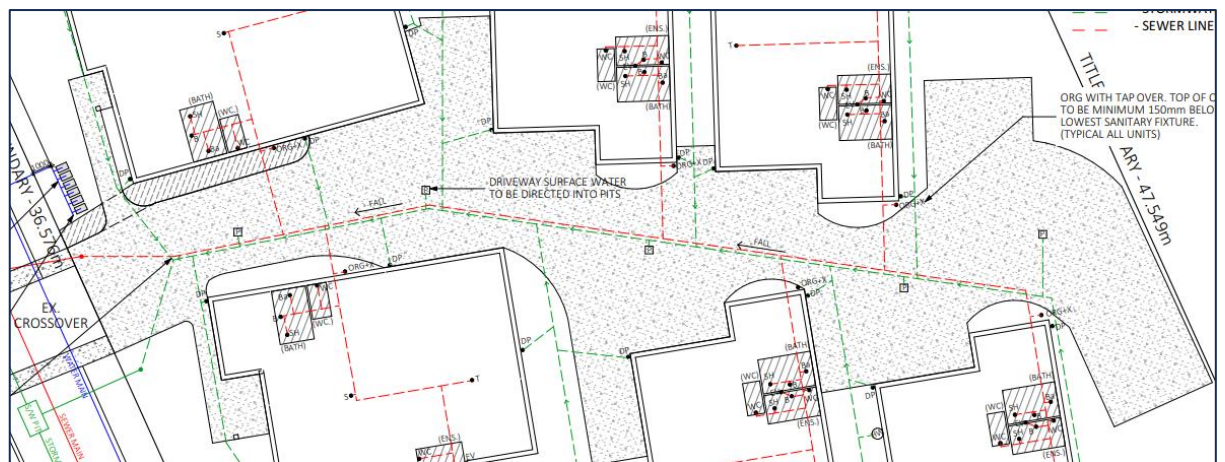
Diagram 7.10 – Management of surface water

The driveway will have a concrete surface with ground pits centrally located, with the driveway camber to direct surface water from the units into the ground pits, which will be connected to an approved stormwater system. The design plans indicate 2.4 percent gradient on the driveway.

C2.6.1 Construction of parking areas.	The parking spaces and internal driveway will be a hard wearing concrete surface, with stormwater pits centrally located and driveway camber directing surface water to the pits, which will be connected to an approved stormwater drainage system. The design complies with the acceptable solution A1.
C2.6.2 Design and layout of parking areas.	The internal layout and parking areas have been designed to comply with both the Australian Standard 2890.1:2004 for user class 1A, and the planning scheme, to ensure vehicles can easily enter, manoeuvre, and leave in a forward-driving direction. There will be sufficient manoeuvring areas adjacent to all the parking spaces to enable vehicles to enter and leave the spaces efficiently. The opening width of the single enclosed garages of units have been made wider to reduce the manoeuvring area and comply with section 5.4 of the Australian Standard 2890.1:2004. Uncovered parking spaces located adjacent to a vertical obstruction greater than 150 millimetres in height, will have an additional 0.3 metres width on either side to assist with

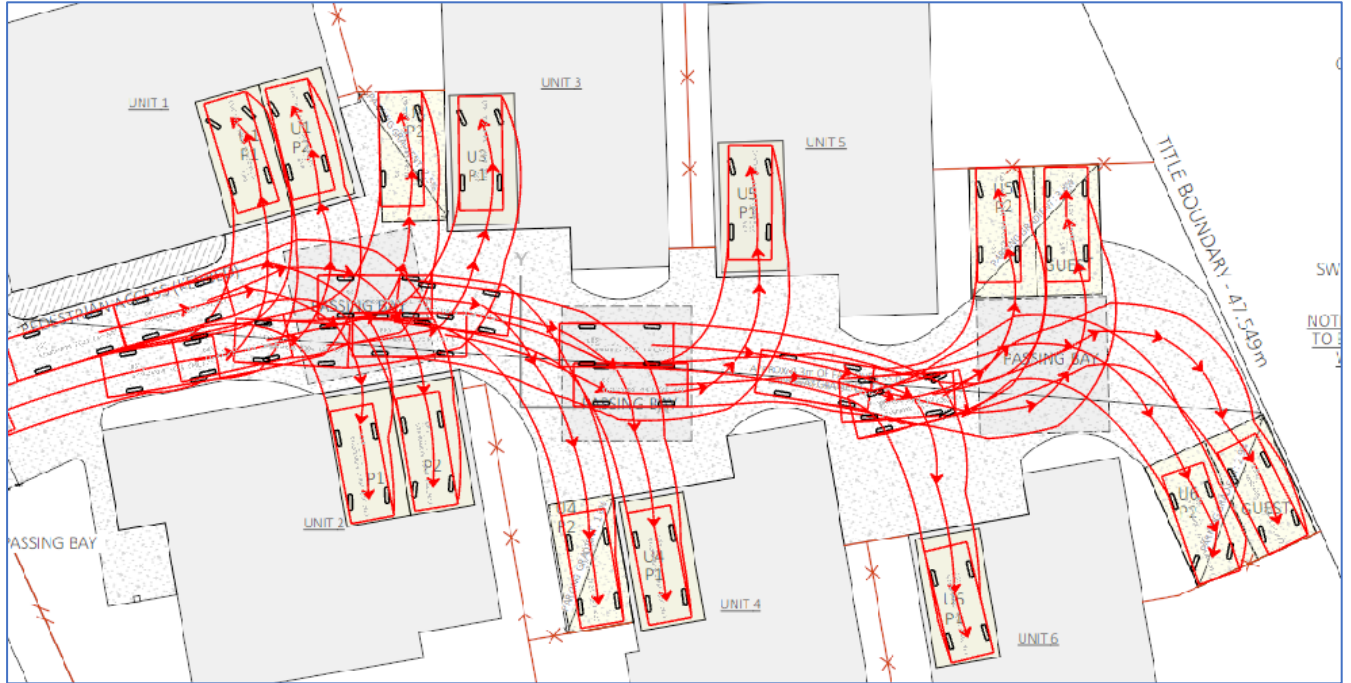
B85 vehicles entering the parking spaces

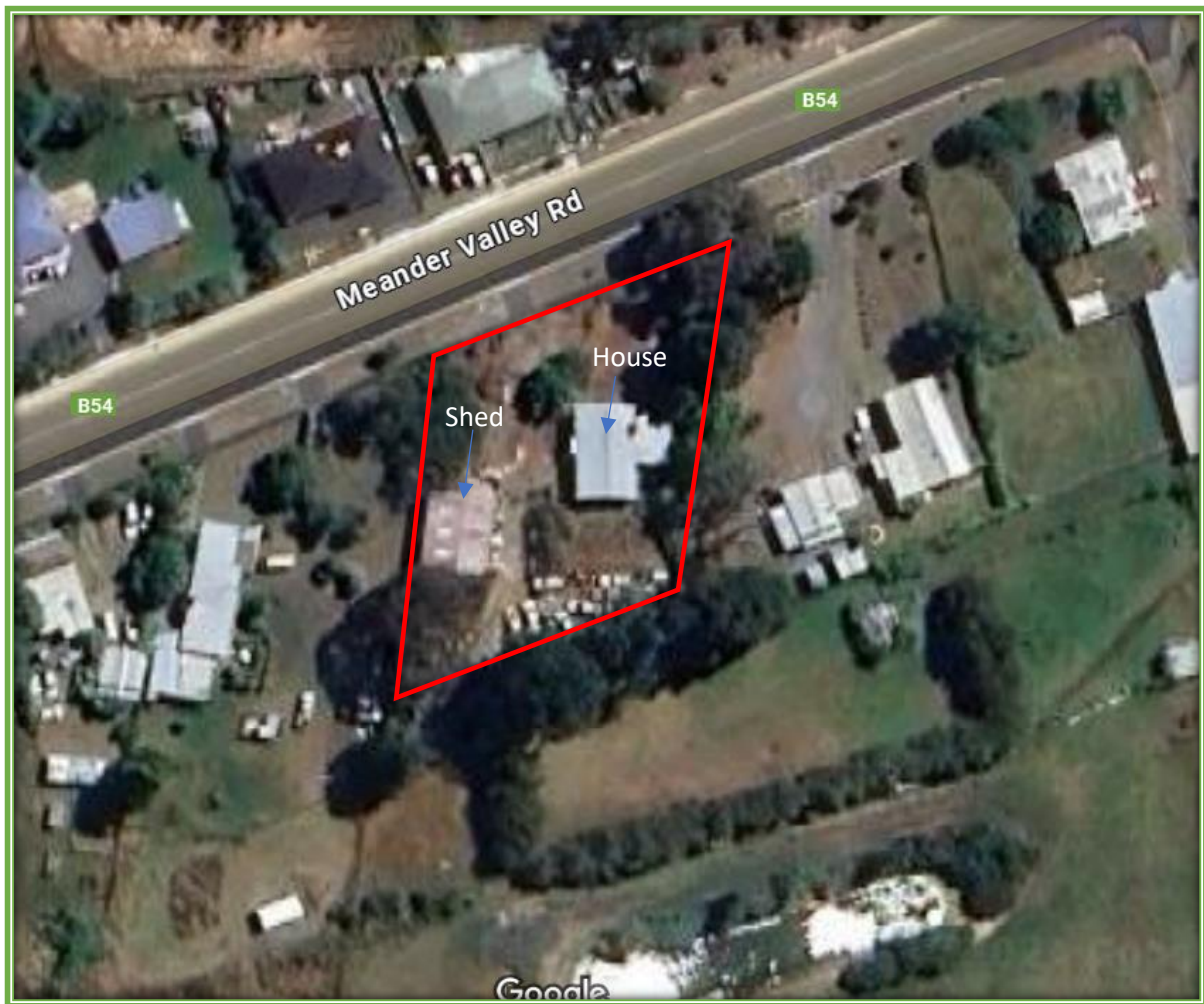
Figure 1: Site and Surroundings

Site layout and location are illustrated in **Figure 1** while pertinent Site information is provided in **Table 1**.

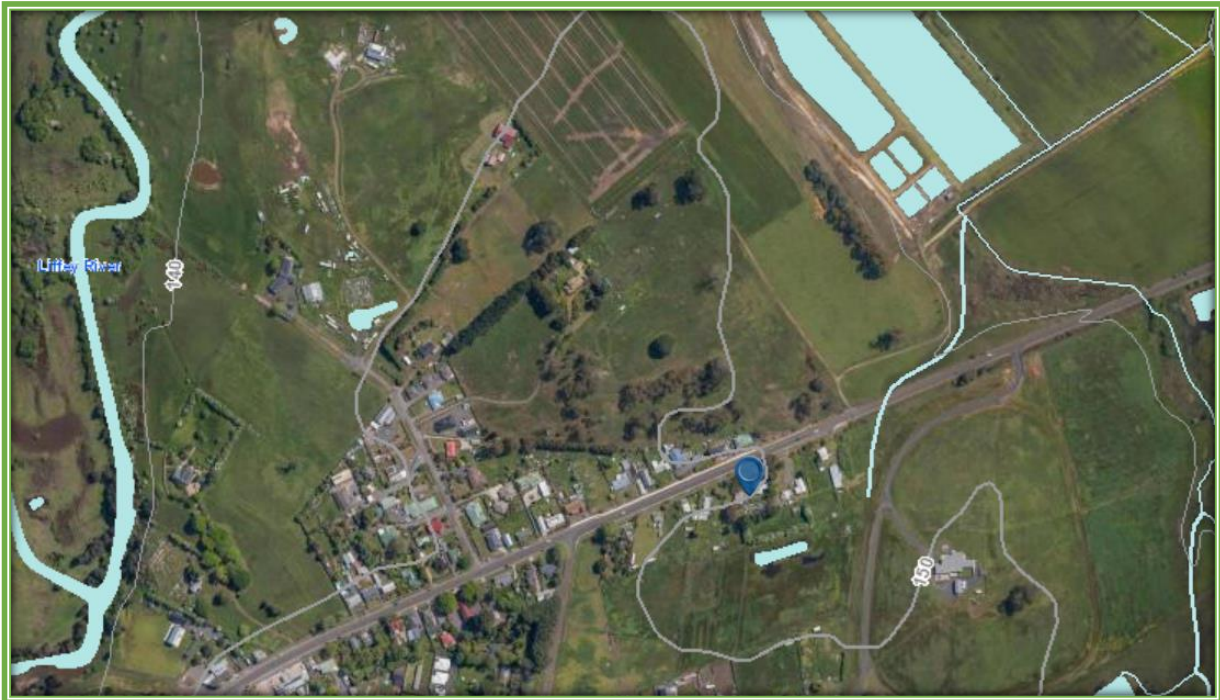
Figure 3: Elevations (m AHD)
(Source NRE Tas, LIST Map)

Groundwater at the Site inferred to flow to the tributaries to the east, which flow to the Liffey River north of the Site or Liffey River to the east. The river is at elevation of less than 140m AHD and the Site is at elevation 150 m. Therefore, groundwater depth under the Site is likely to be greater than 10 metres. Refer to **Figure 3**.

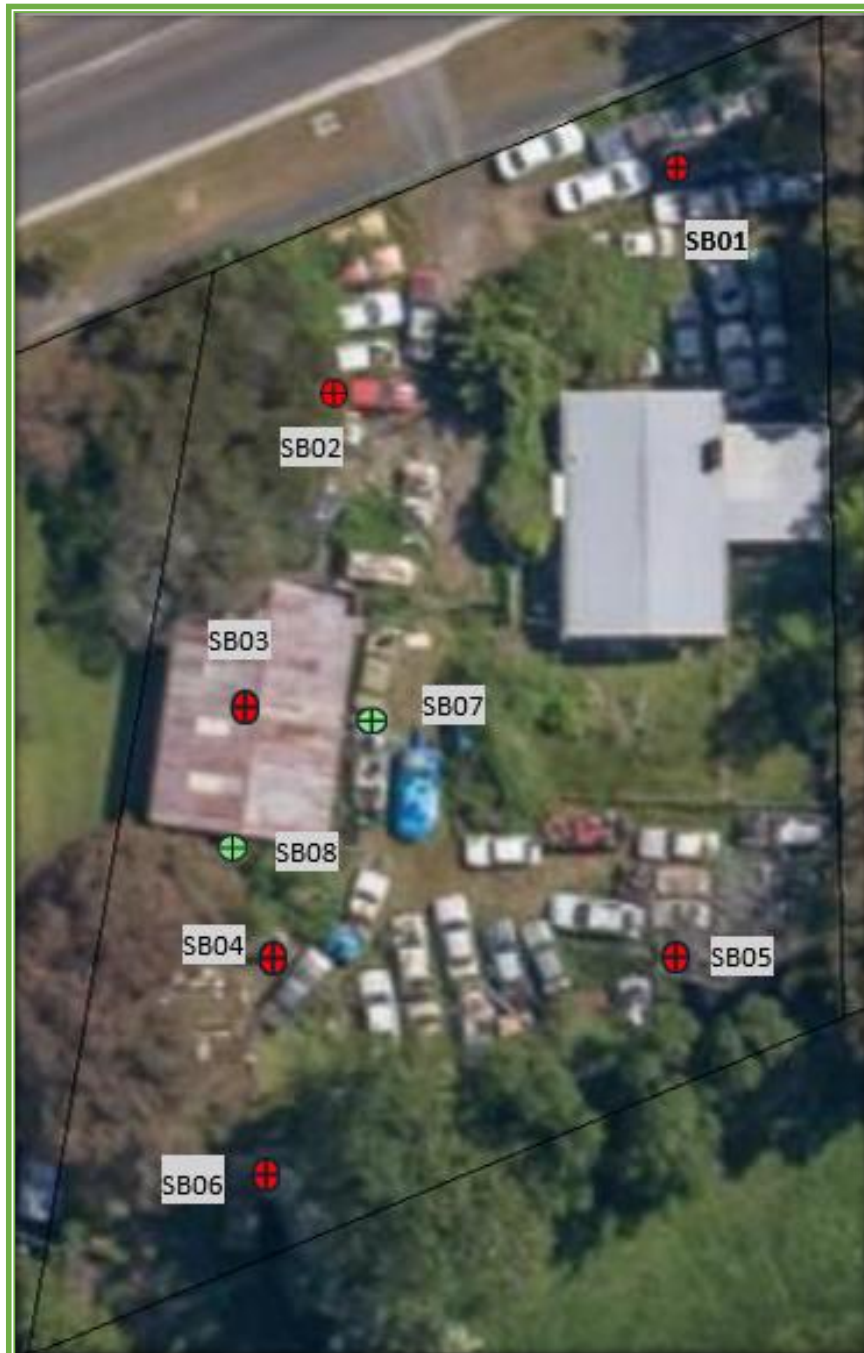
Figure 4: Soil Sampling Locations

To assess actual soil conditions, a targeted and non-judgemental soil sampling program was completed. The scope and methodology are detailed in this section. Soil sampling locations are illustrated in **Figure 4** which illustrates former vehicle storage.
